Remedial Actions at Hazardous Waste Sites
Survey and Case Studies

SCS Engineers
Covington, KY

Municipal Environmental Research Lab.
Cincinnati, OH

Jan 81

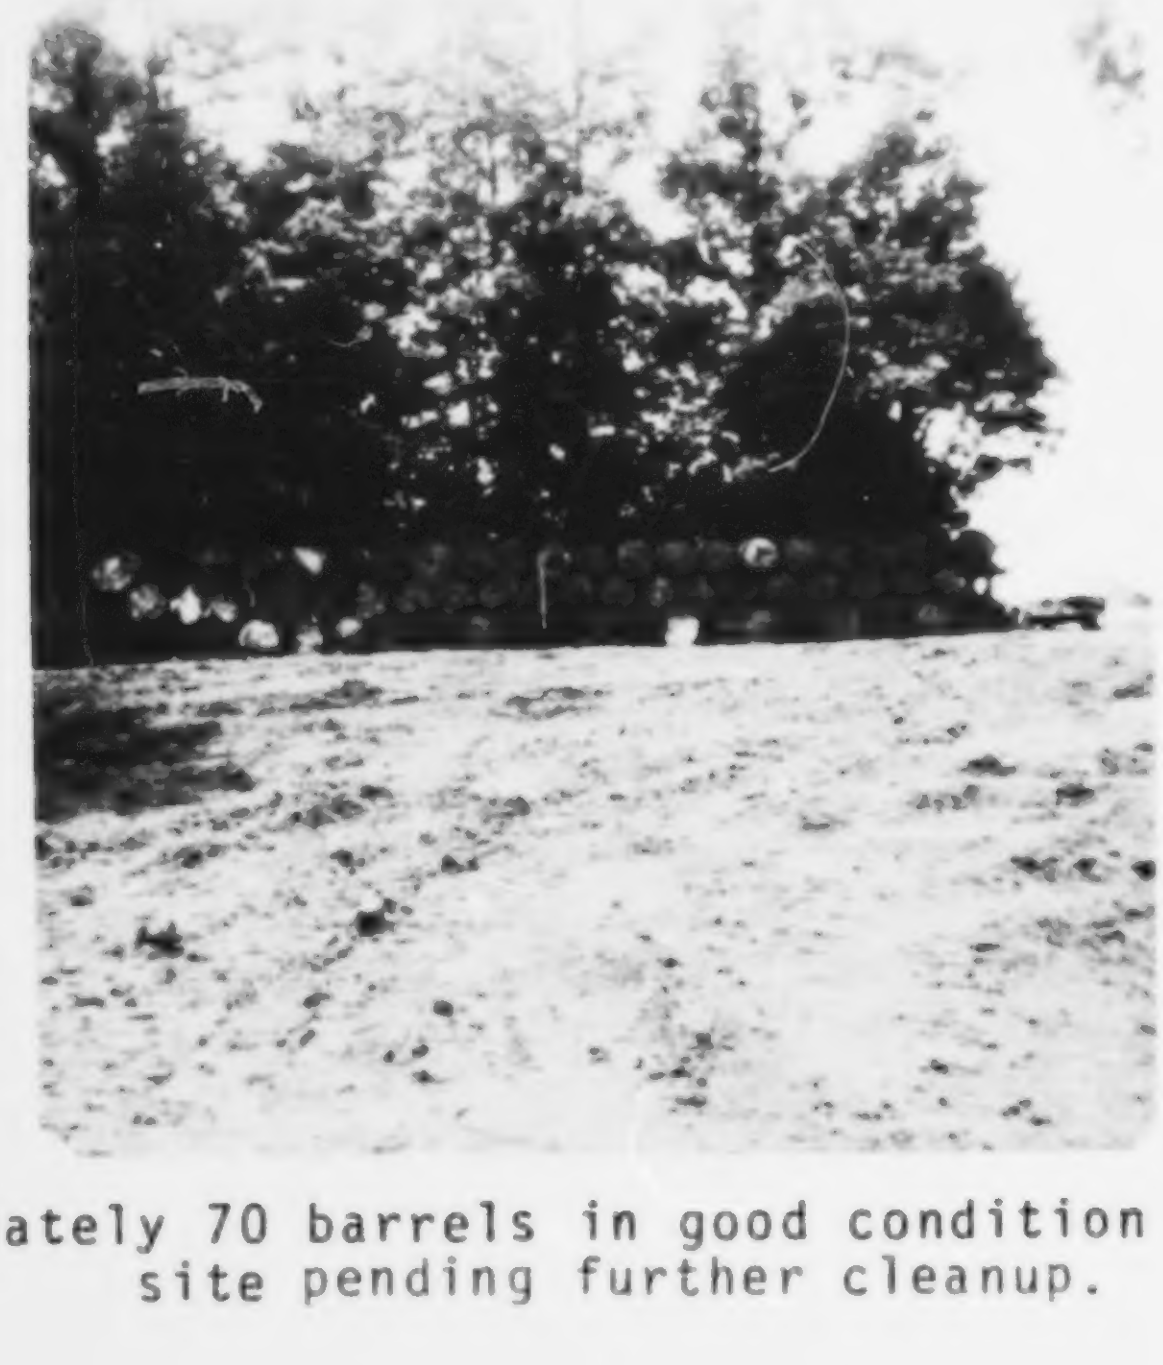
Approximately 70 barrels in good condition left at site pending further cleanup.

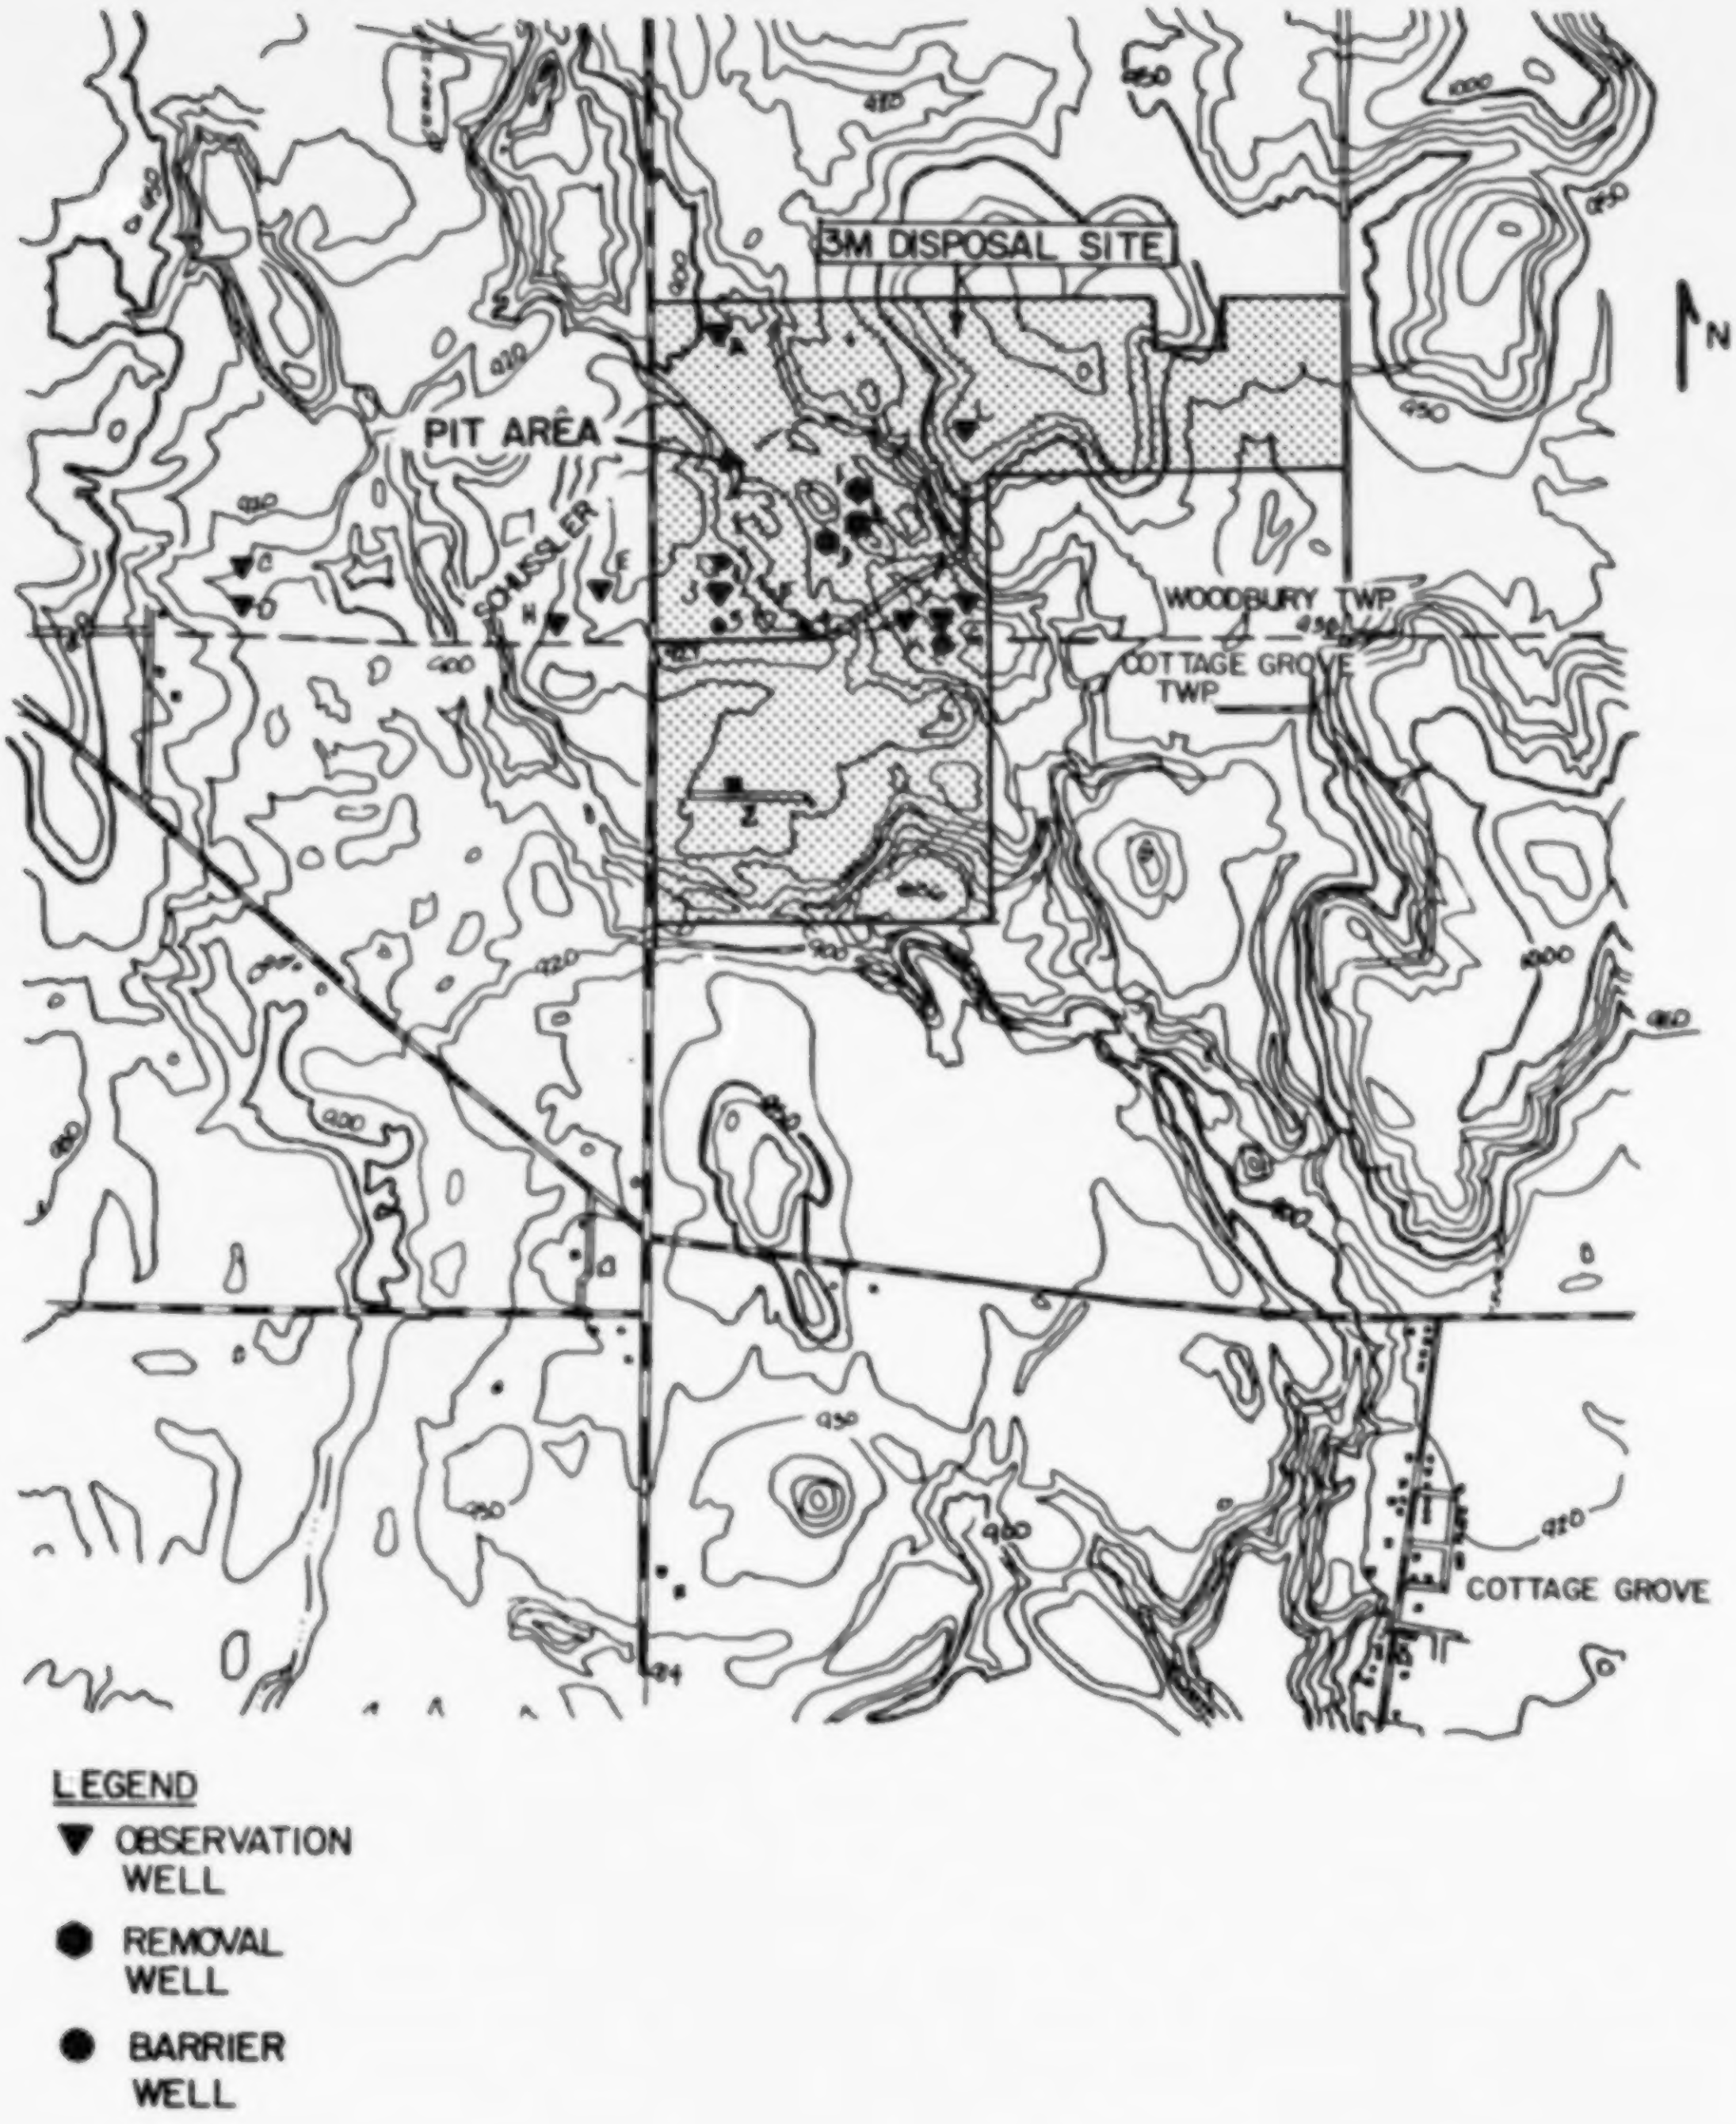
Figure 9-4. Location of contaminated Schussler well and barrier wells. [9-1, 9-3]

schedule. The 10 wells that are presently being sampled are located in glacial material and have shown no contamination except for nitrates from barnyard runoff. Schussler's well was the only well found to be contaminated with organics. As a result of barrier well water withdrawal, the glacial perched water was drained and Schussler's well went dry in about 1970. Subsequently, a new well was installed for the Schussler residence, which retrieves ground water from the Jordan Aquifer. Figure 9-5 exhibits the combined concentration of isopropyl ether and other compounds at the old shallow Schussler well. The new Schussler well has never shown any isopropyl ether contamination.

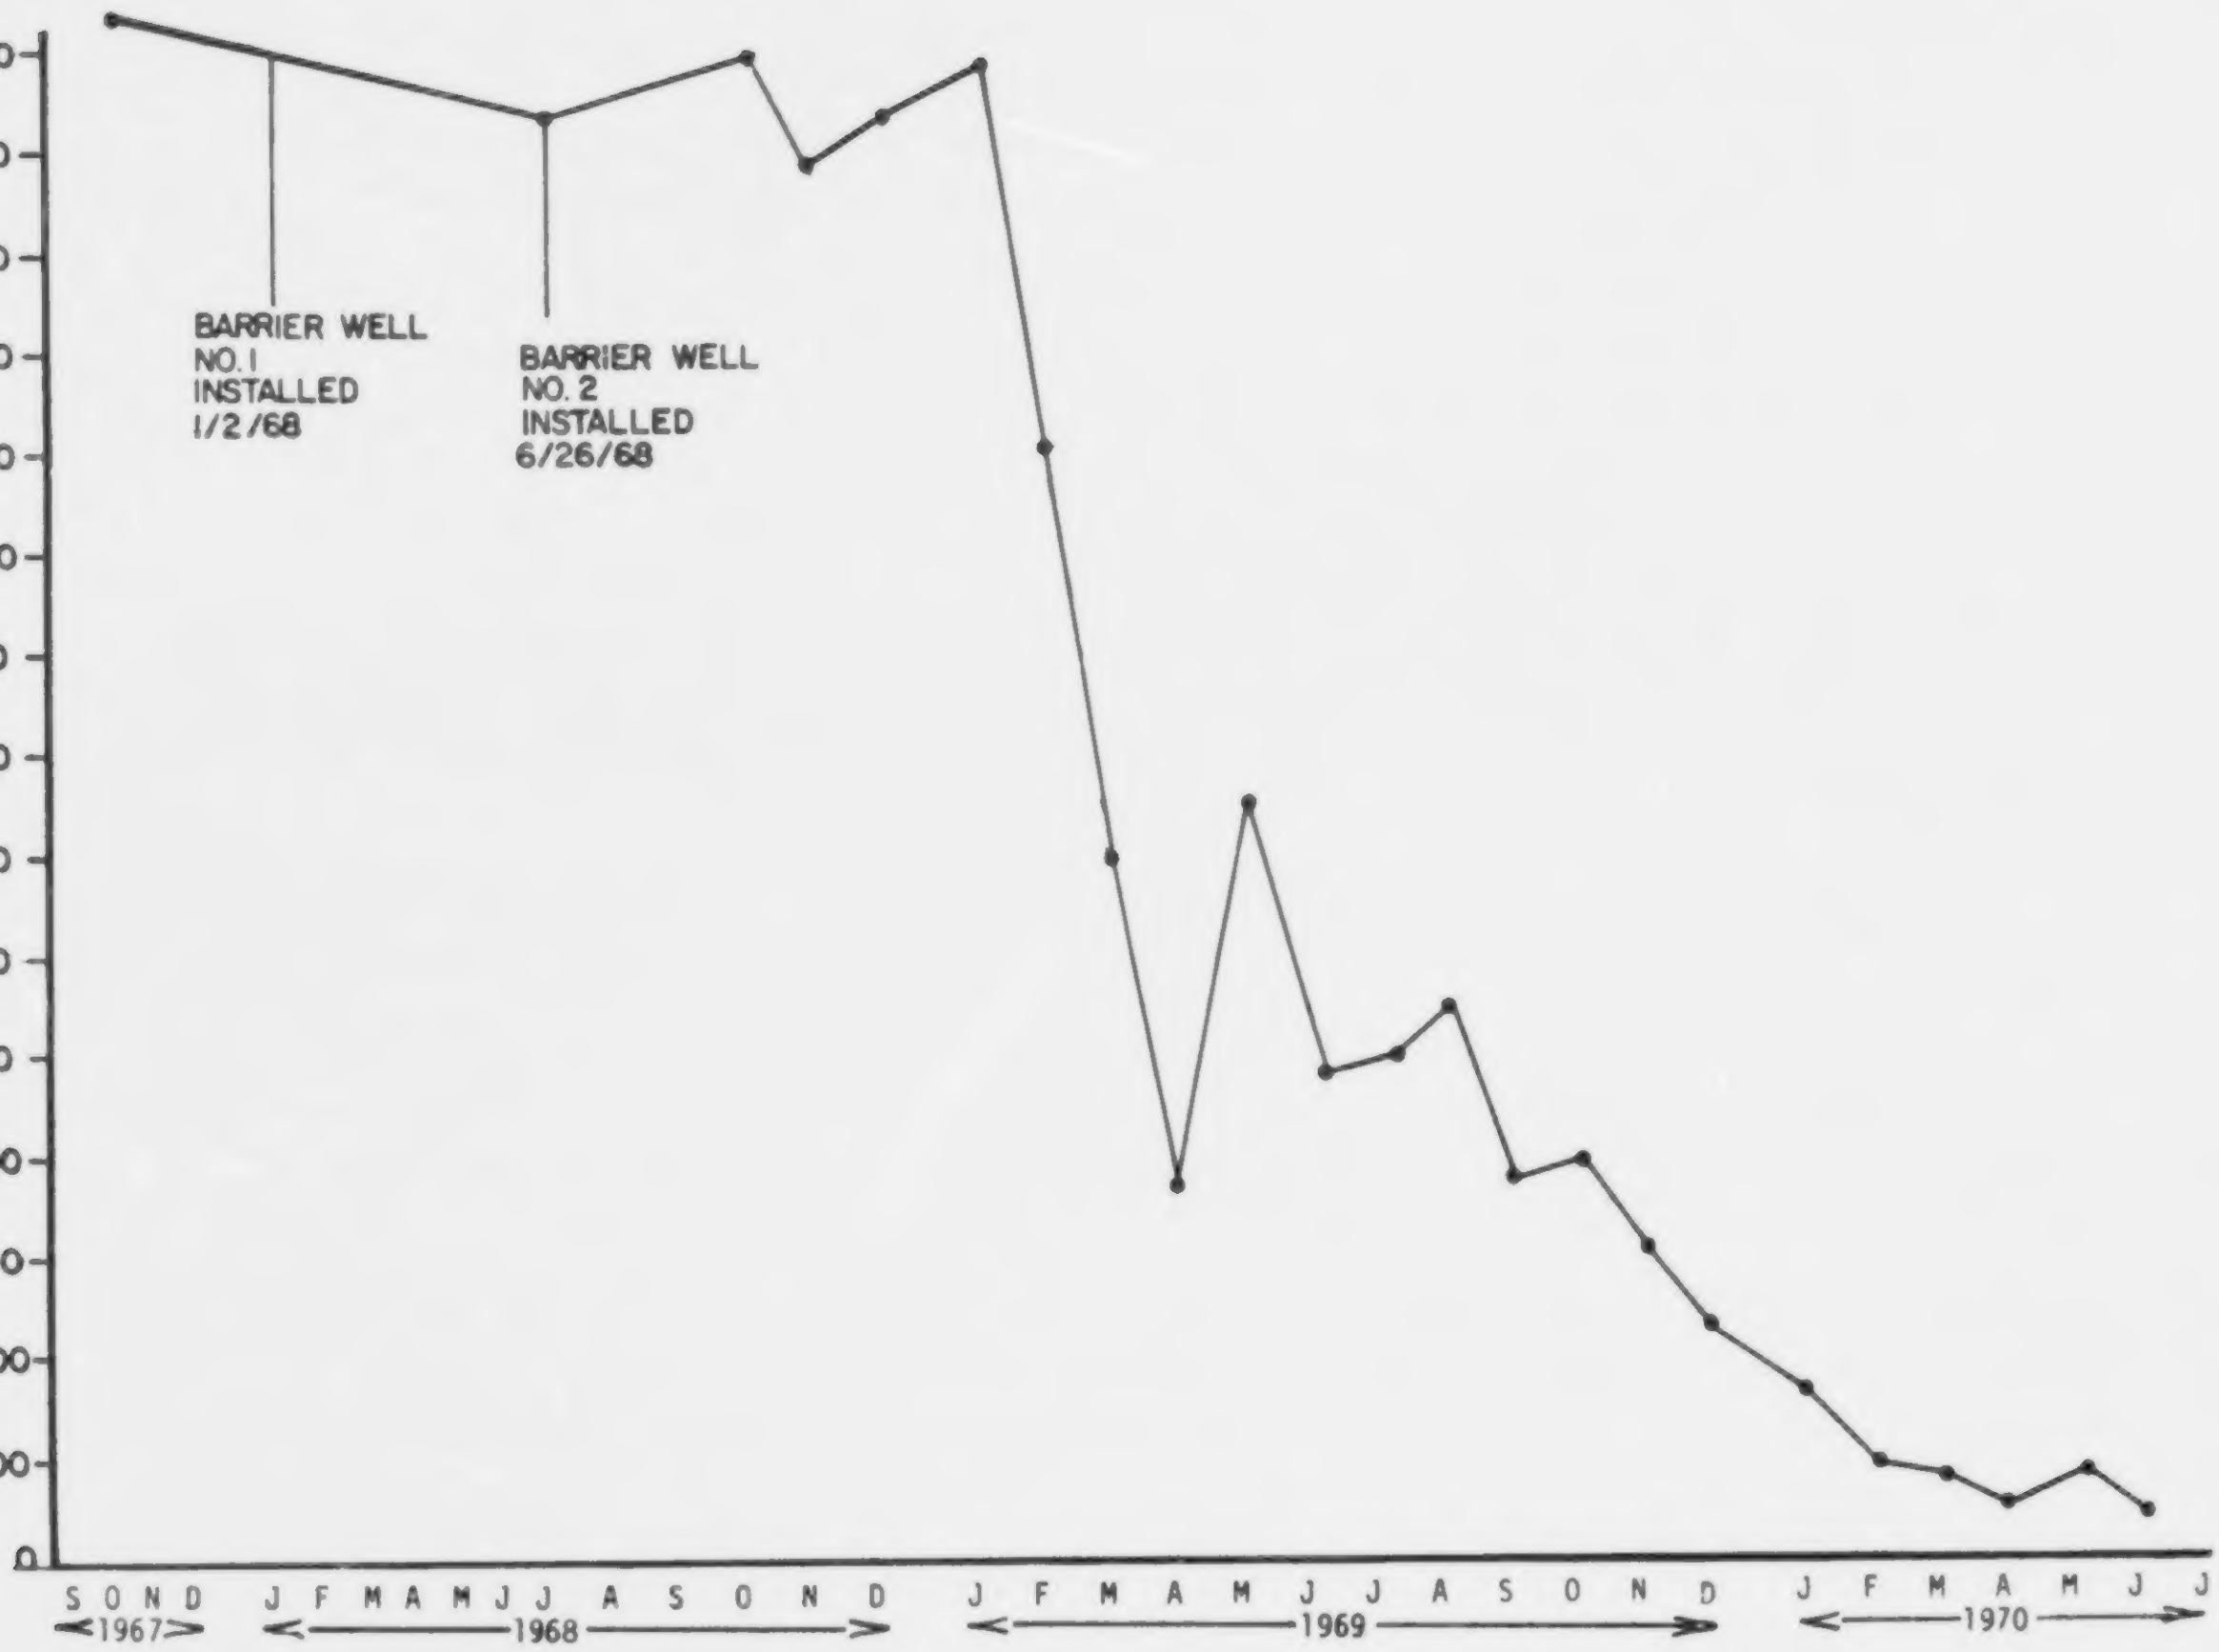
Figure 9-5. Sum of the concentration of isopropyl ether, isopropanol, and dichloromethane for shallow well at Schussler residence.

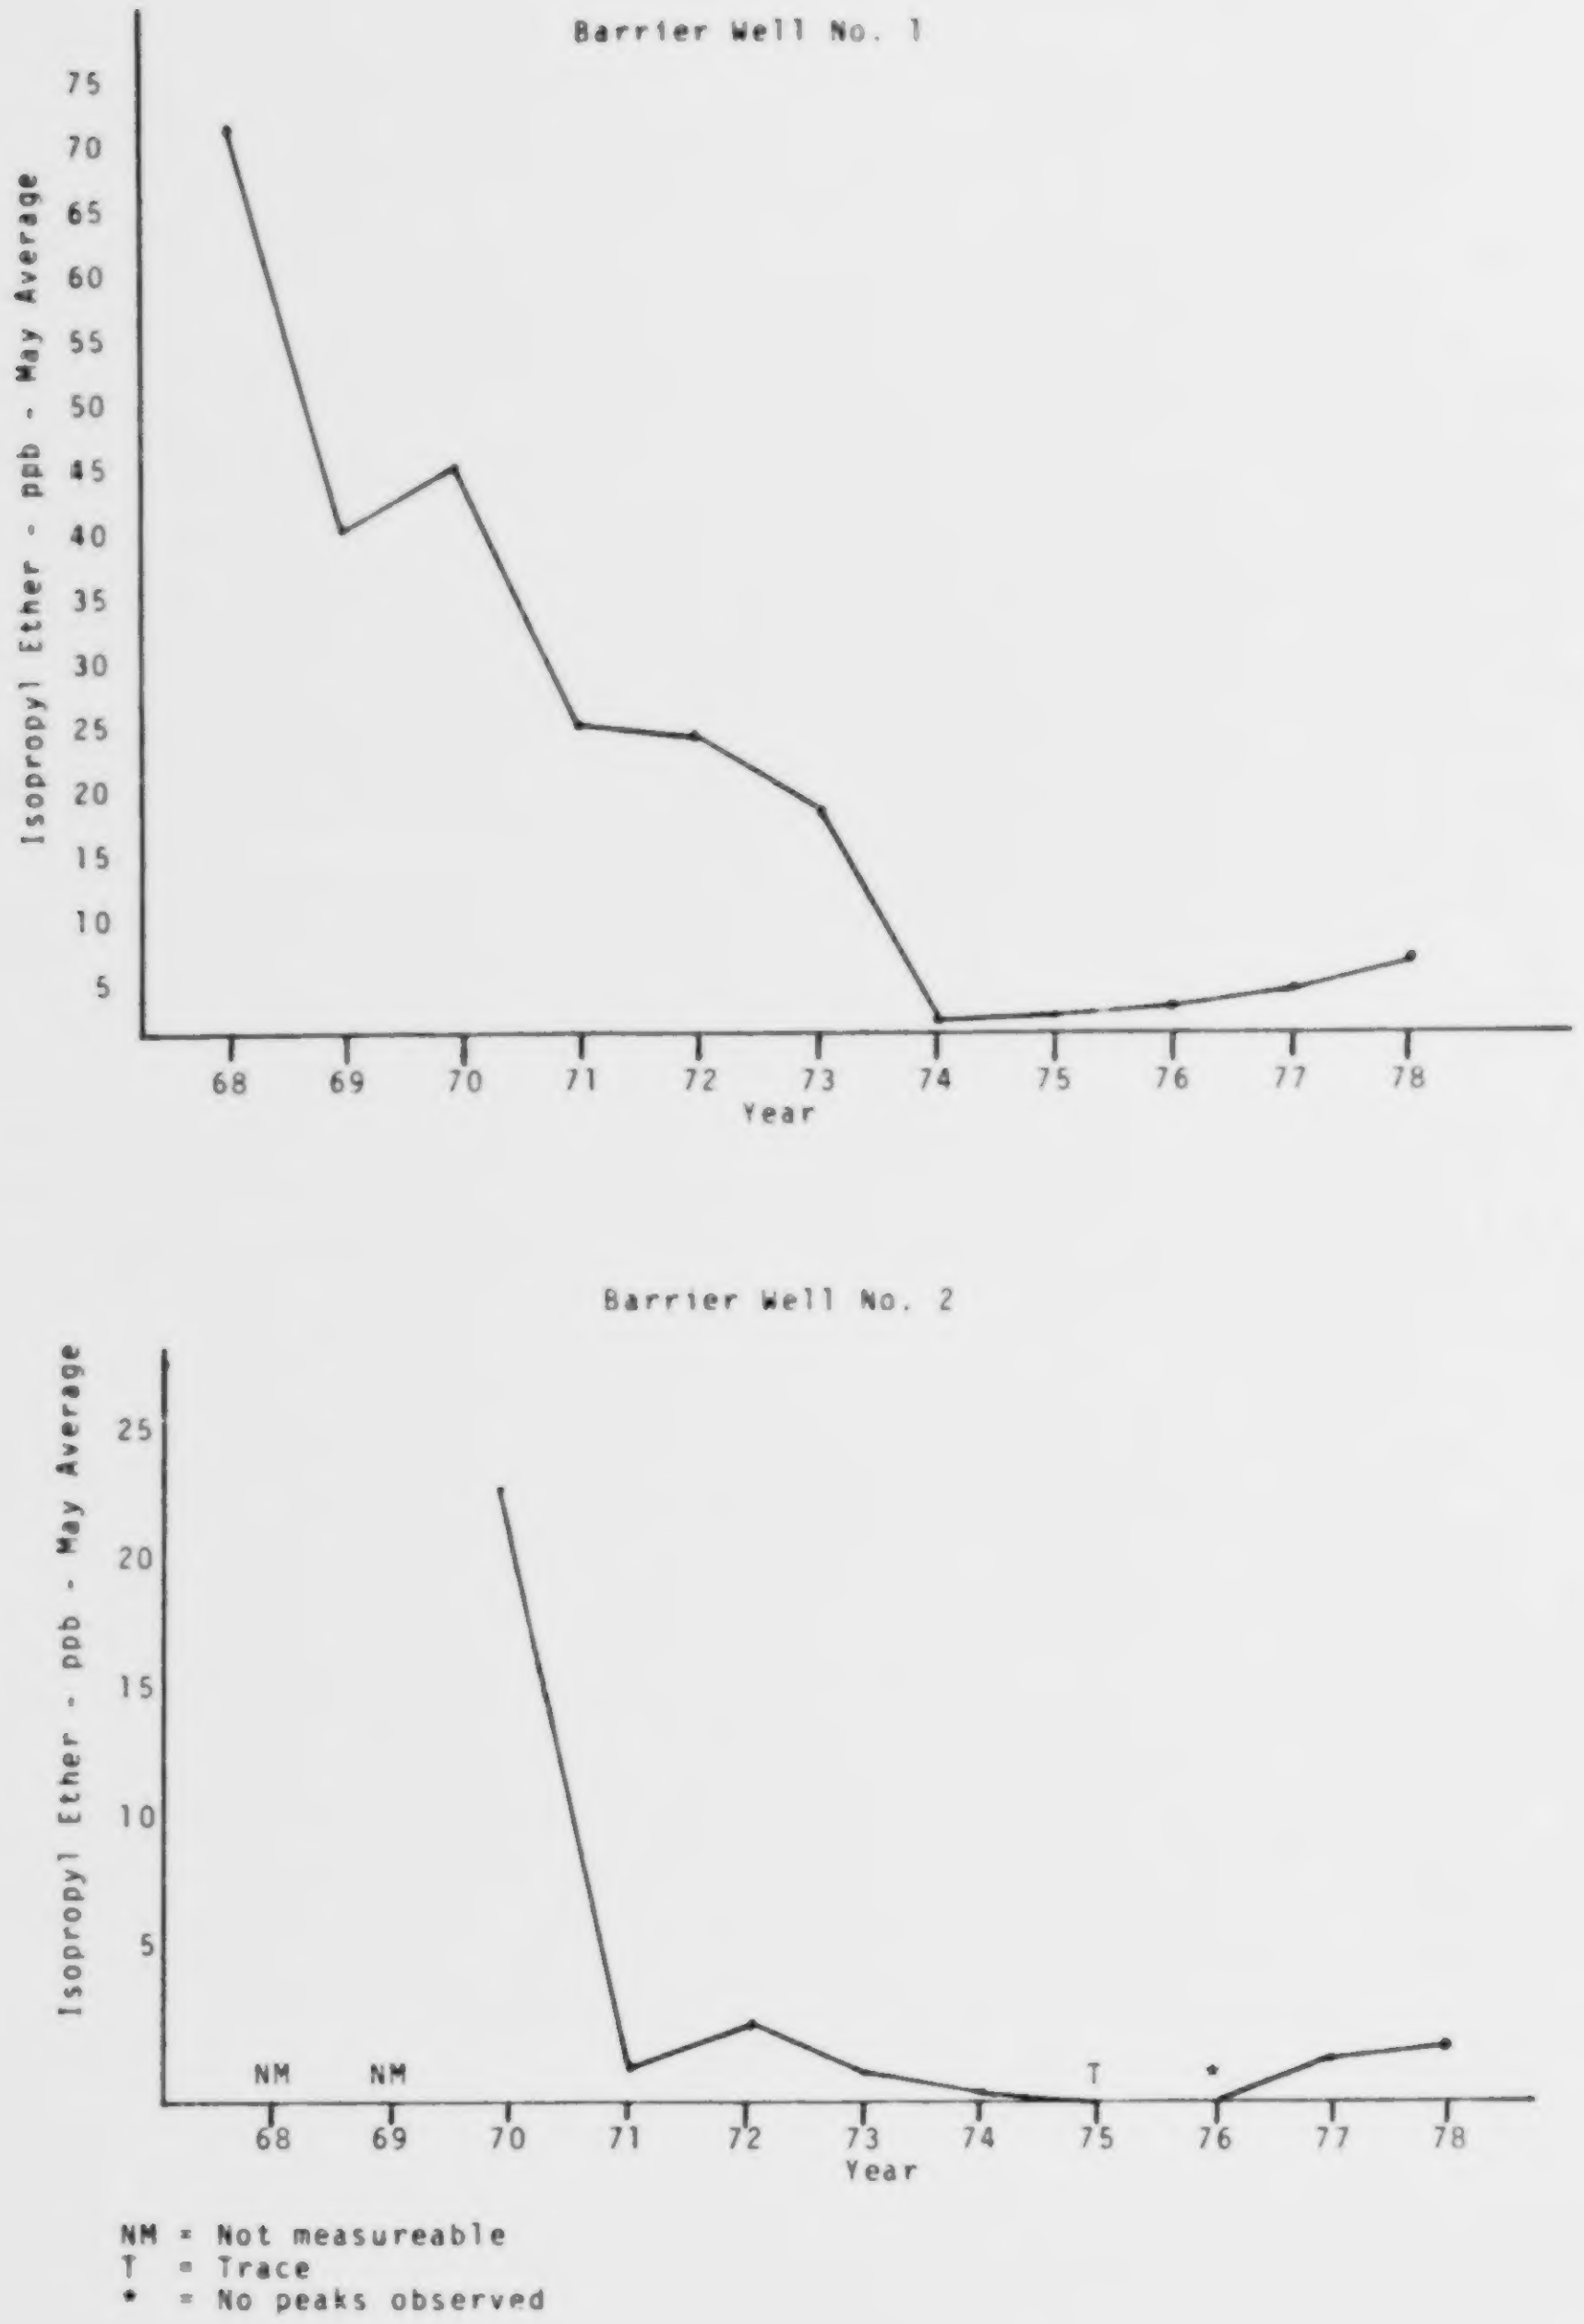
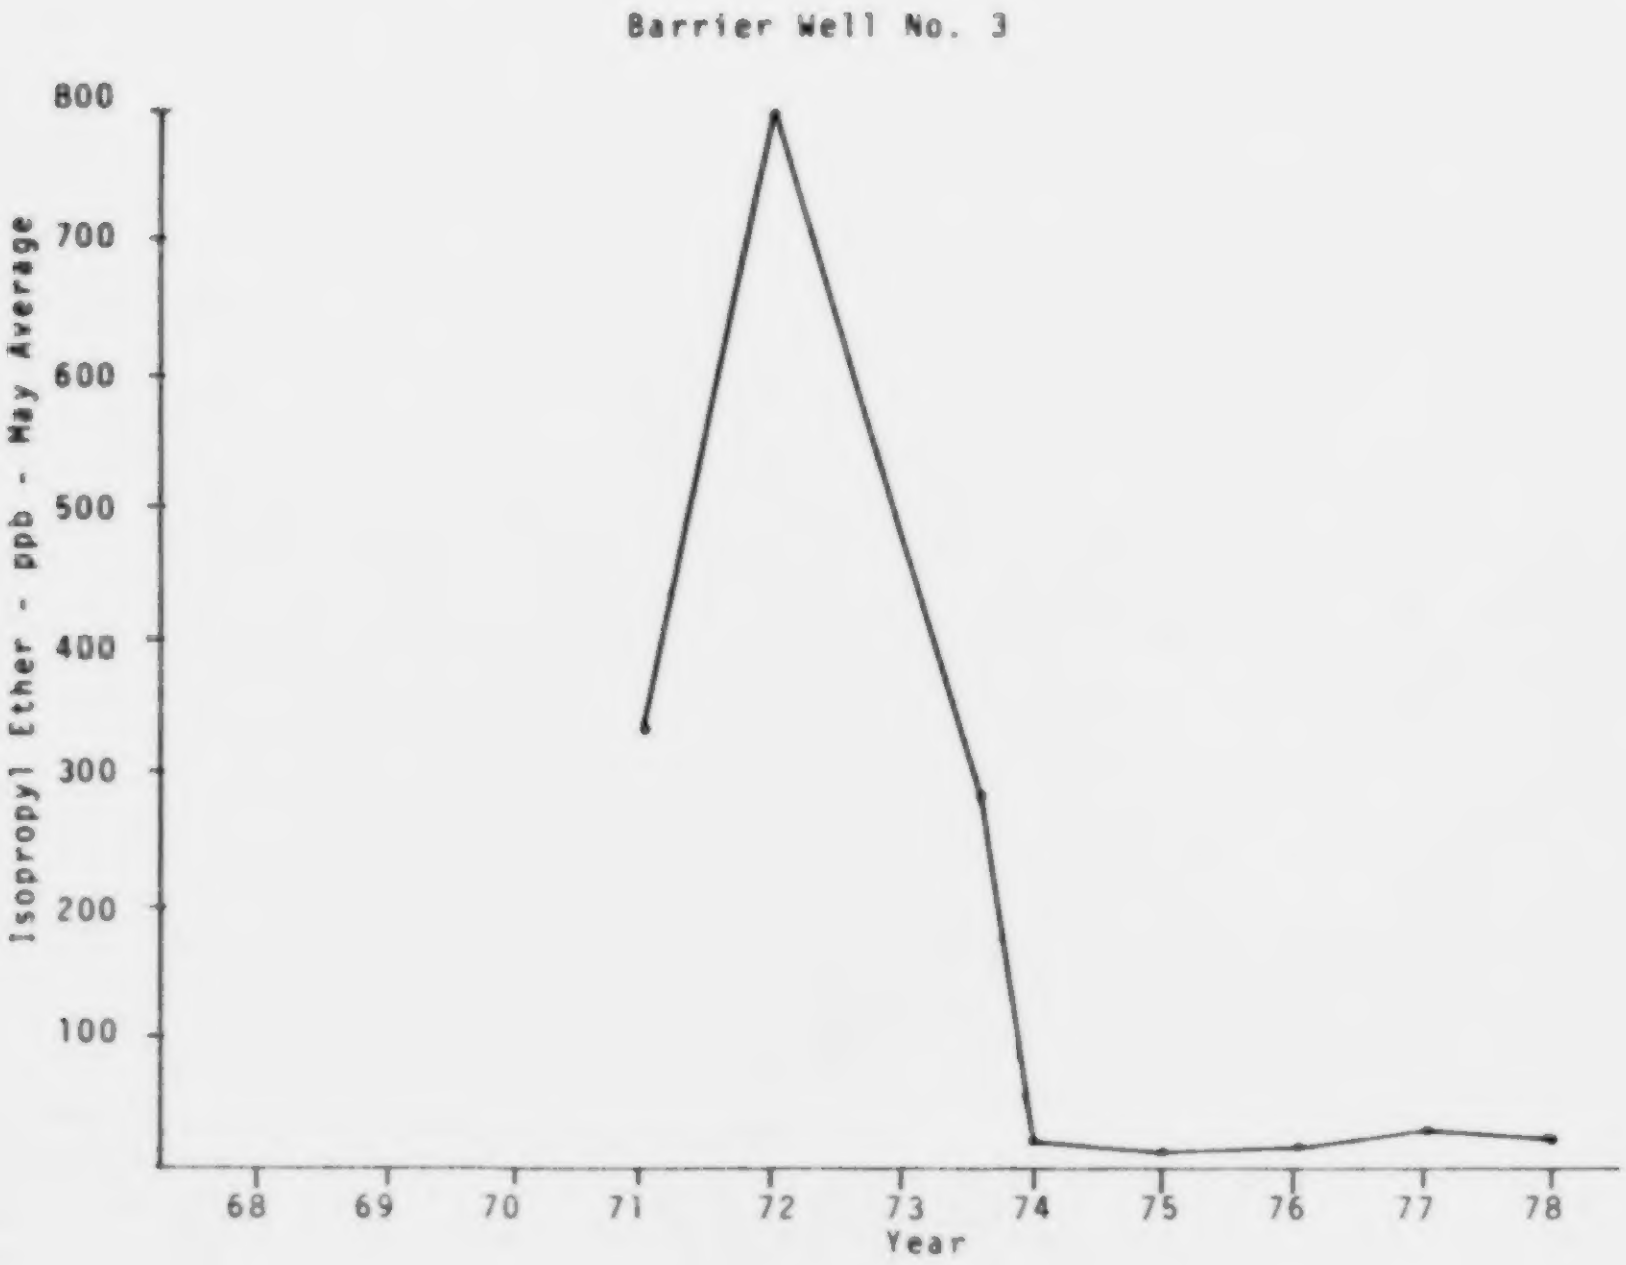
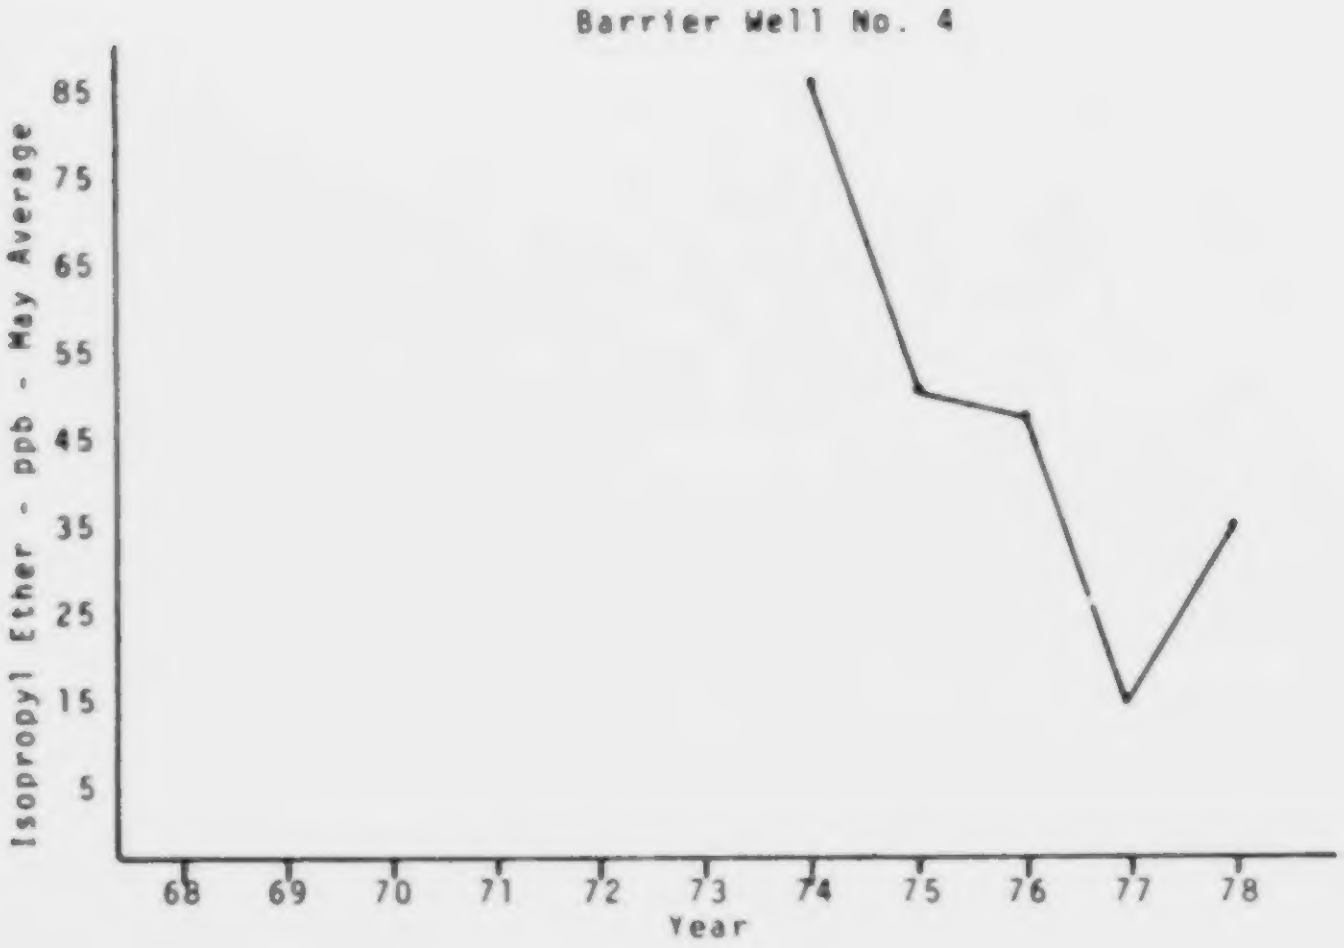
Table 9-1 provides performance data on the four barrier wells. (The location of these wells was shown in Figure 9-4.) Figure 9-6 demonstrates that a decrease in concentration of isopropyl ether has been experienced since the introduction of the barrier wells. Table 9-2 displays 19 priority pollutants which were found in the discharge water. The discharge system consists of a 10 km (6 mi) underground forcemain privately owned by 3M and which allows effluent discharge into the Mississippi River. The forcemain consists of 5,000 m (16,400 ft) of 46 cm (18 in.) diameter iron pipe and 3,286 m (10,782 ft) of 46 cm (18 in.) diameter asbestos cement pipe. After pumping water through the forcemain, the water flows down-gradient to the Chemolite facility, and is discharged into a ravine which empties into the Mississippi River.

Figure 9-6. Graphs of isopropyl ether measurements for Barrier Wells Nos. 1 to 4.

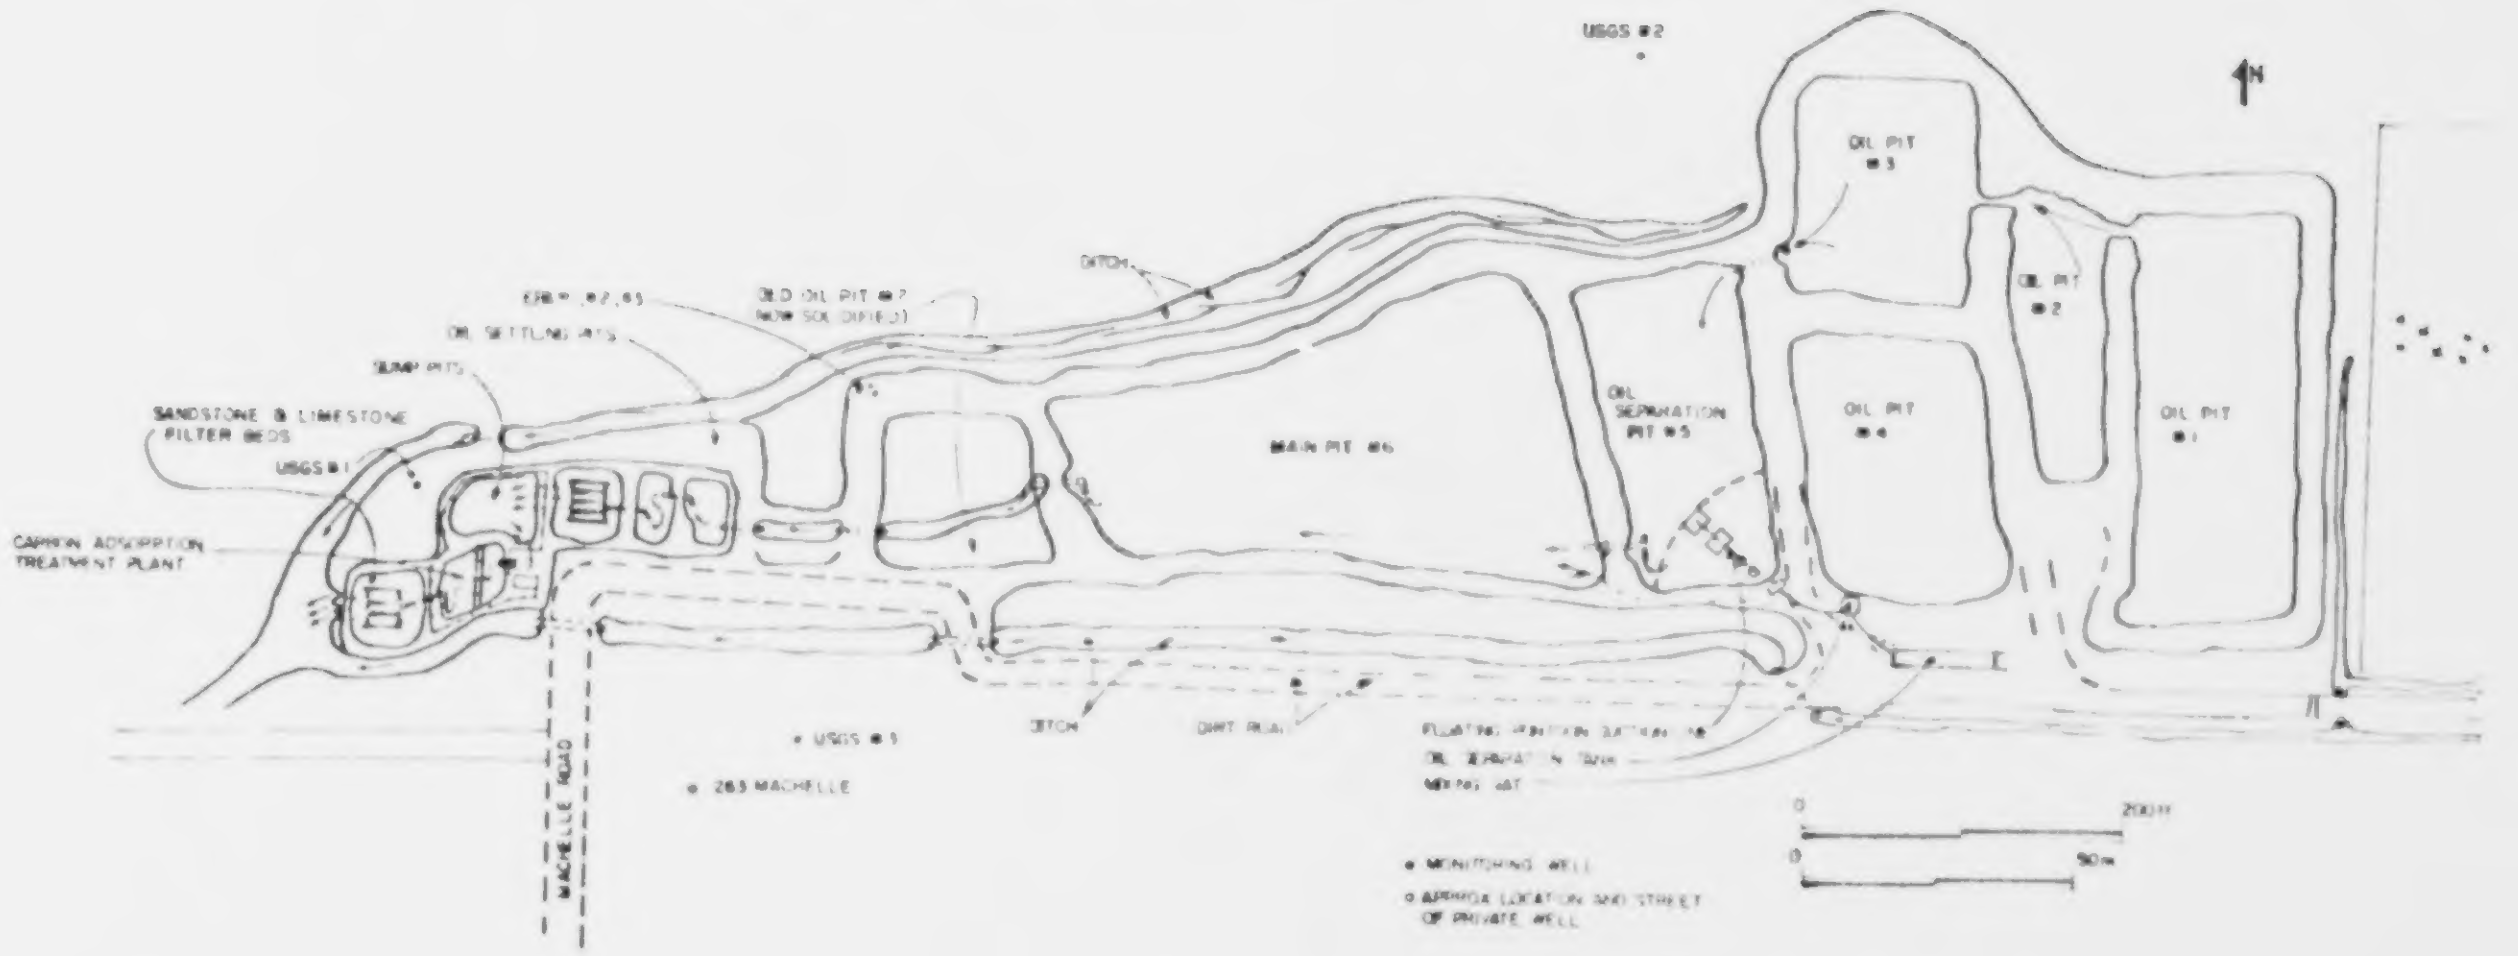
Figure 10-3. Layout of Whitehouse oil pits and diversion ditches (1976).

On several occasions levees from the waste oil pits ruptured following heavy rainfalls. In 1967 Pit No. 7 ruptured spilling its contents onto adjacent private property and into McGirts Creek. The City of Jacksonville Mosquito Control Branch, recognizing the threat of other pits rupturing if the water level was not controlled, began to build a two cell oil/water separator in conjunction with a limestone filtering system in an attempt to dewater the pits. The City attempted to reinforce the ponds' retaining walls to prevent further pollution problems in 1967, 1972, and 1974. An attempt was made to have the Whitehouse site declared a mosquito control project, along with an adjacent swamp area since the swamp could not be properly drained without addressing the oil pits first. The request was denied by the Florida State Bureau of Entomology in 1974. In 1975 an attempt was made to obtain Florida State Department of Environmental Regulation pollution restoration funds to rectify and close out the problem area. This request was also denied.

To compound the situation, erosion caused by motorcycle and four-wheel drive vehicles weakened the retaining berms. On June 29, 1976, after abnormally heavy precipitation, the retaining berm of Pit No. 6 on the western edge of the site collapsed during some minor repair work by Mosquito Control Branch personnel. The resulting breach allowed approximately 757 m^3 (200,000 gal) of the captured waste oil material and an undetermined amount of highly acidic water to flow into McGirts Creek and the adjacent natural water collection basin. An oil spill emergency was declared and the U.S. Coast Guard, a private consulting firm, and the Bio-Environmental Services Division (BESD) of the Jacksonville Department of Health, Welfare, and Bio-Environmental Services were mobilized under the direction of the Oil Spills Group of the EPA Region IV Environmental Emergency Branch. Cleanup measures were initiated on the evening of June 29, 1976.

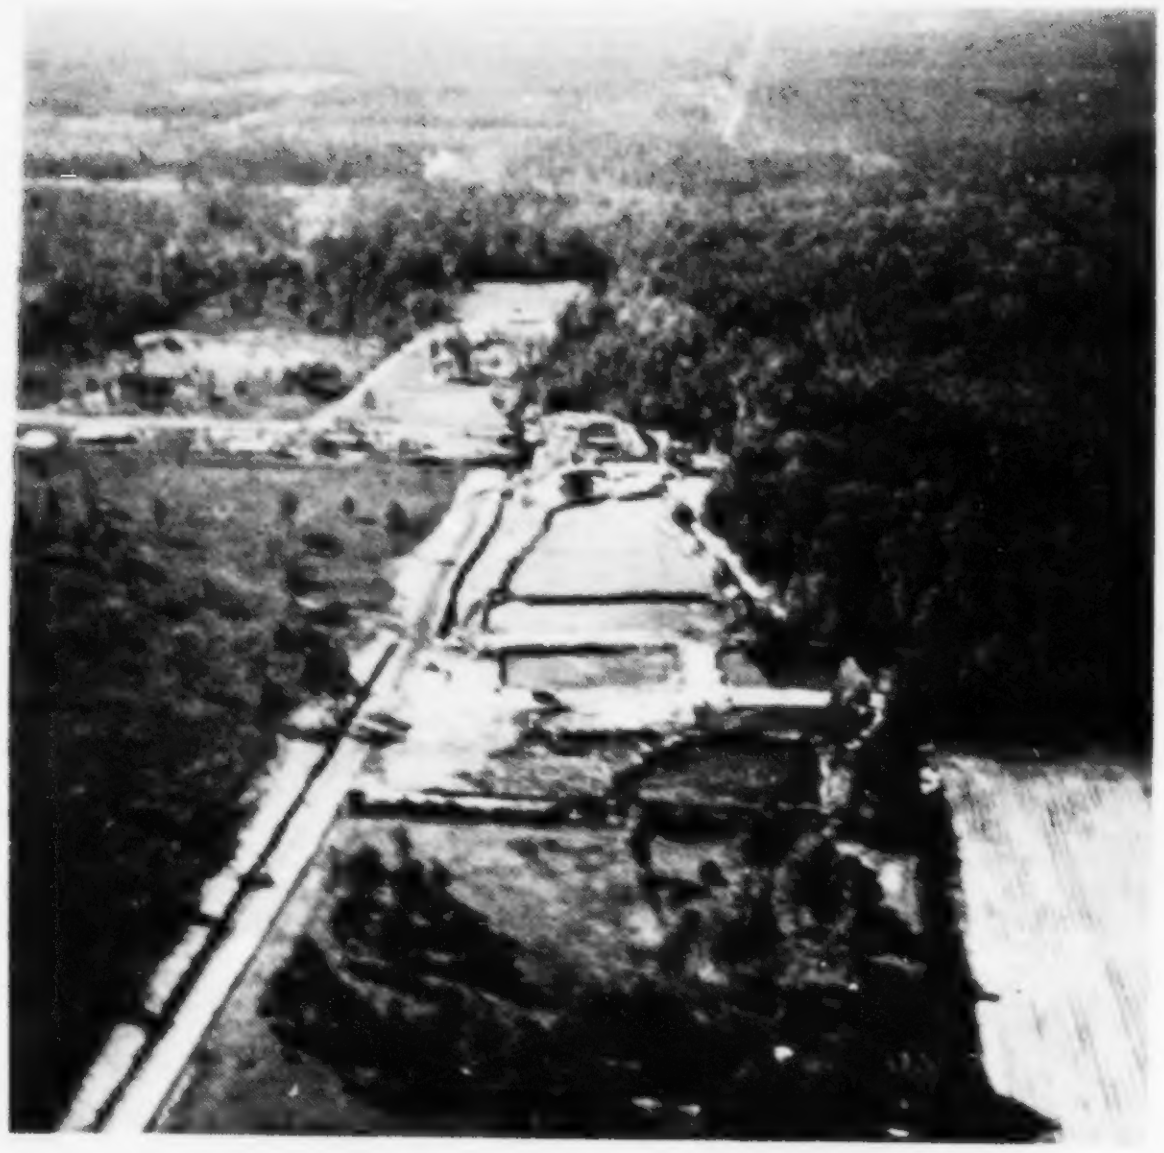
Aerial photograph of the Whitehouse oil pits (1976).

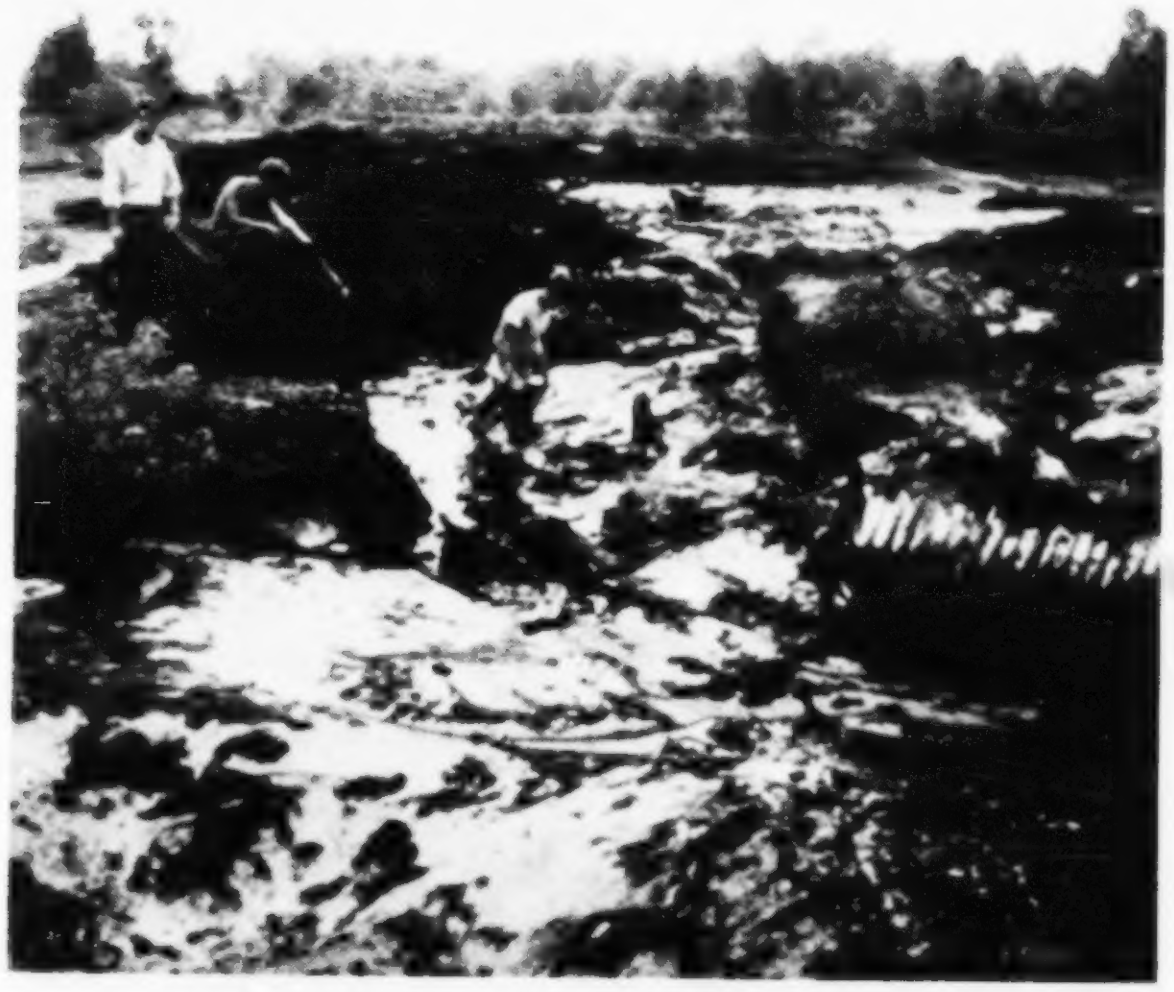
Oil flowing to McGirts Creek from ruptured pit (1976)
